TECHNICAL

YOU AND YOUR GEARSHIFT CABLE --things that you have never wanted to ask and, now that you know, you will not sleep nights

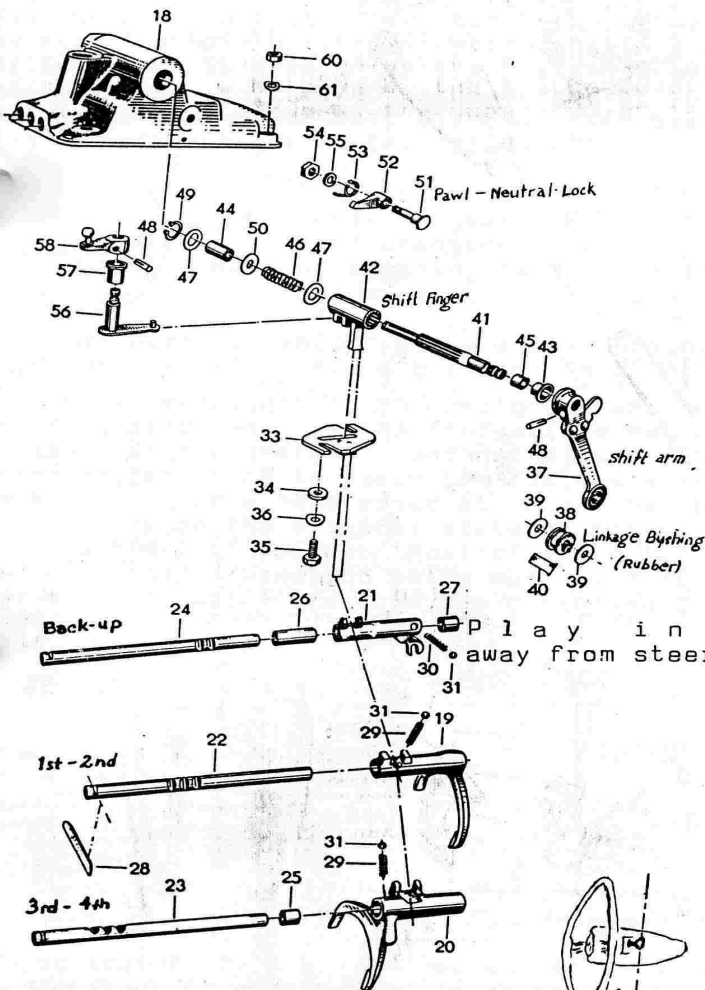
The gearshift cable --or "crossshift cable", as it was known in Chrysler autos of the late 1930's-- hooks one of the three shift forks in the top of the gearbox (key #'s 21, 19, 20) for the gears Back-up/ 1st-2nd/ 3rd-4th to the shift arm at the side of the gearbox by means of the shift finger (#42). The shift finger is spring-loaded to keep it from slipping into the reverse fork (#21), but it slides freely (without any spring action) between the strike forks for 1st-2nd (#19) and for 3rd-4th (#20).

Play here means that silent block (key # 4) is broken. This is changed by removing horn button, steering wheel --depending upon how well the silent block is held on by the flattened-over end of the shift tube, you may also need to remove the upper end of the steering column (held on by set screw #52) pivot bolt #11 and shift bracket #3. This aluminium housing is often tight on the column #51.

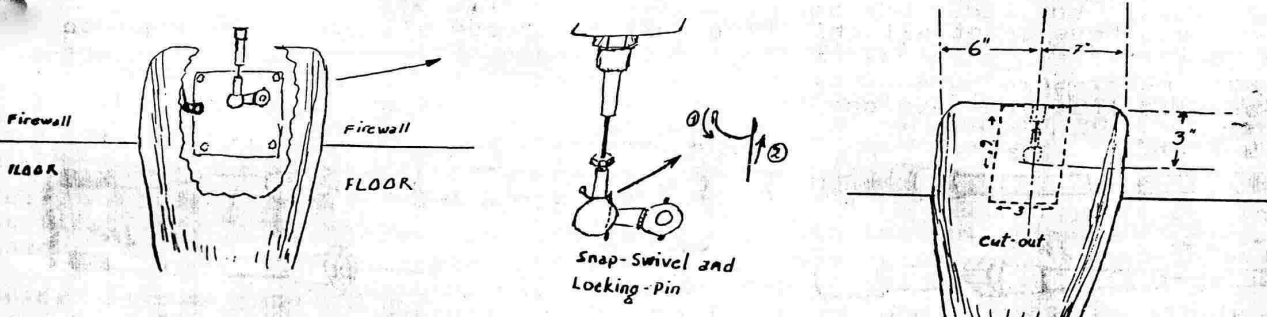
Perhaps an oversight of the designers was not to have put a reach-hole into the gearbox hump at the firewall to get at the lower end of the shift-cable at the gearbox. Such a hole, by the bye, was put into the trunk floor in late 1960 to reach the fuel-tank sender without need to pull the tank out. Such a hole added at this time for the shift cable would, of course, change the original state of the car. The decision is yours -- but, be tidy! if you do. Most of the cut-outs that I have seen are quite sloppy. The information below was taken from my defenseless Combi into which a one-foot-square hole was butchered (not by me!!) for this very purpose.

If you truthfully M U S T cut a hole into Isabella, all that you need is a hole about 6" x 3" beginning at the firewall.
